Case report Patent zirconia implant

Dr. Harald Fahrenholz
Dentist

4. April 2020

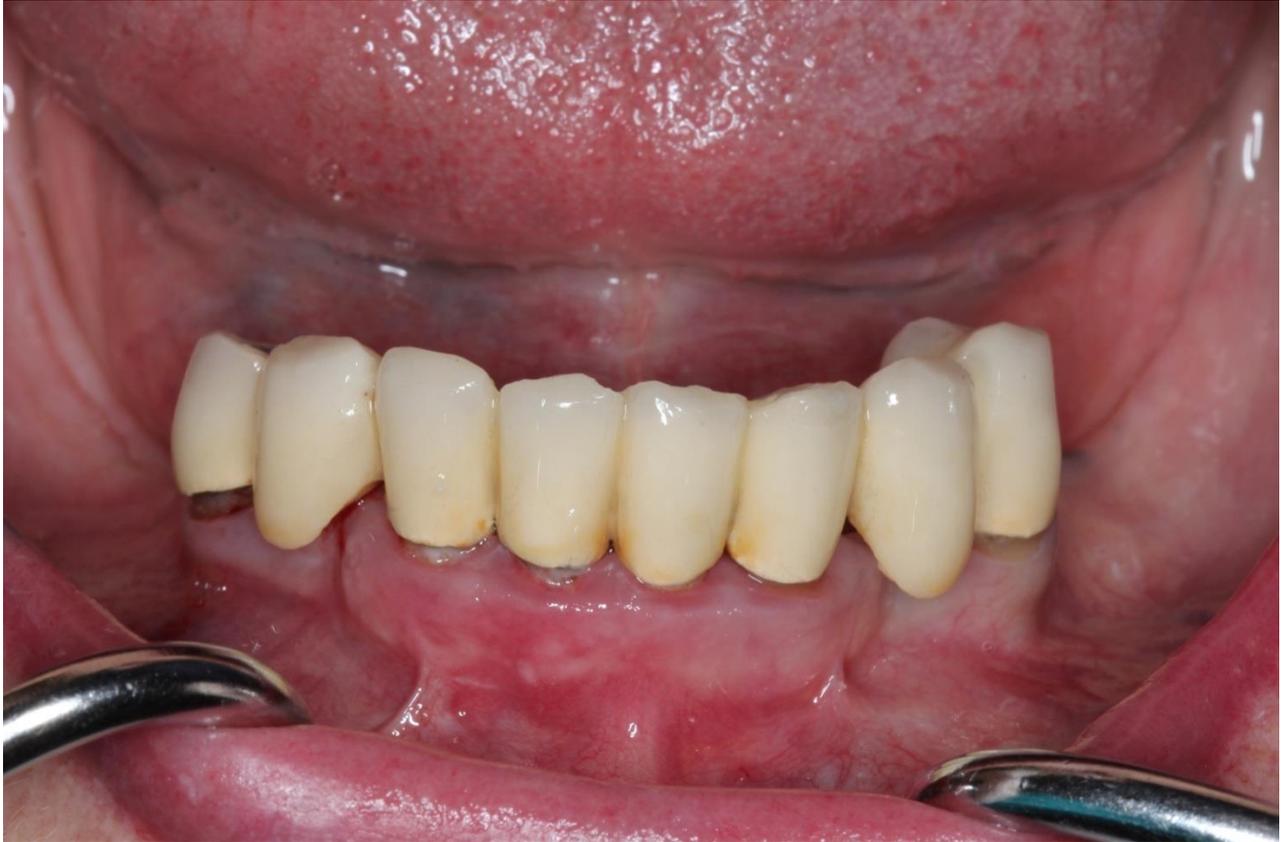
Figure 1: initial situation with the over 20 year old bridge.

70 year old female patient presented at the author's office, asking for a general restoration of her teeth in the lower jaw. She had a more than 20 year old bridge from 34 – 44. The teeth 33 and 43 were bridge pontics (Figures 1 and 2). Because of periodontitis marginalis profunda (Figure 3) it was decided, with the patient's consent, to extract all teeth and to place ceramic implants in the same session. The next decision was to make a fixed bridge or a removable overdenture. The patient preferred a bar retained overdenture to facilitate cleaning and maintenance. Why a bar? The bar retained overdenture is easy to handle for technicians, dentists and patients. The cleaning is a little bit more difficult with for example an overdenture on telescopes. In the upper jaw the patient already had a removable denture so it was no problem for her to handle this.

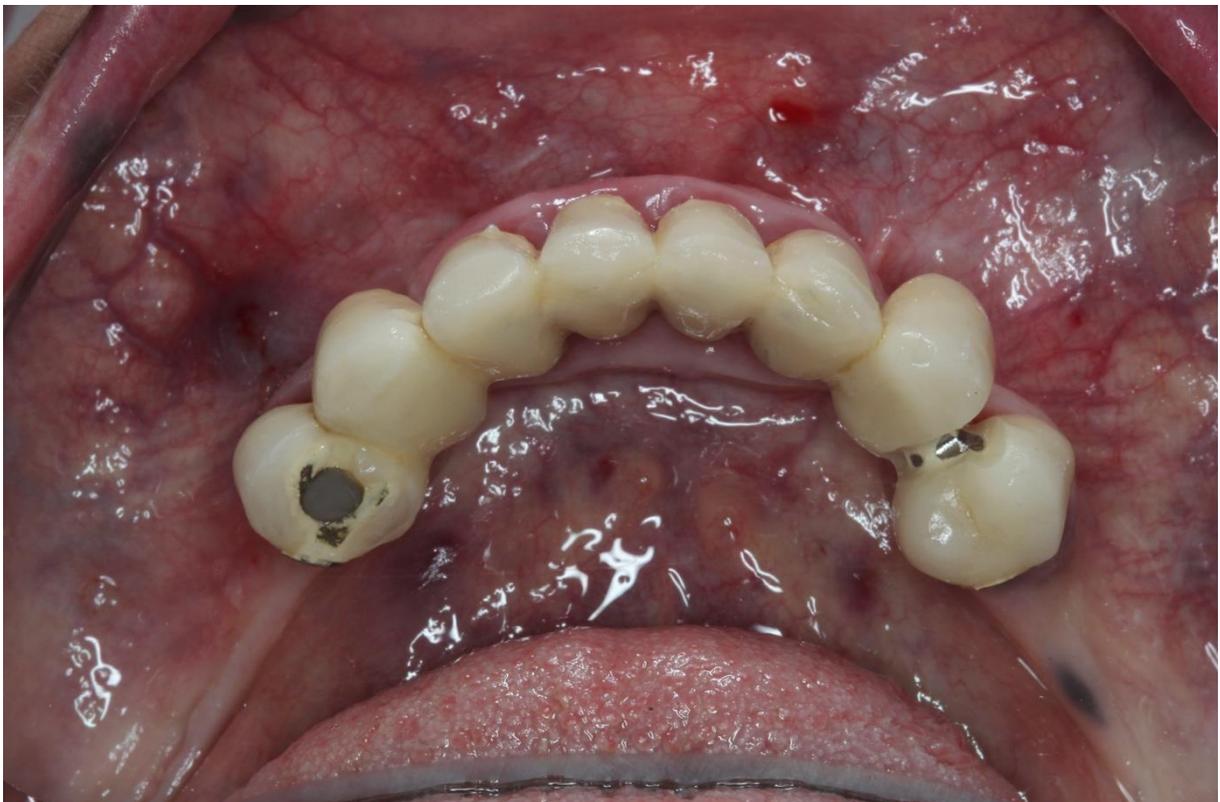
Figure 2: Initial situation, occlusal view.

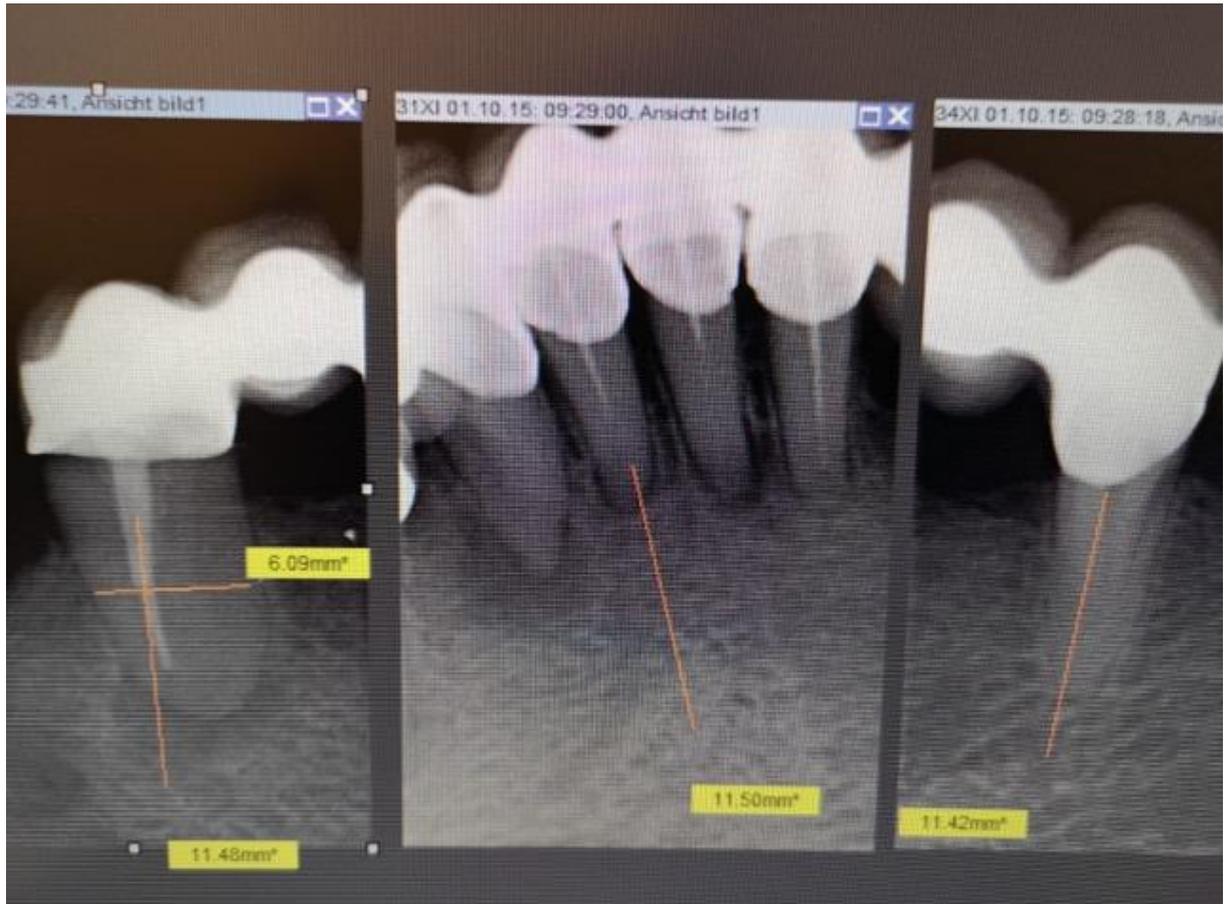
Figure 3: Situation before extraction

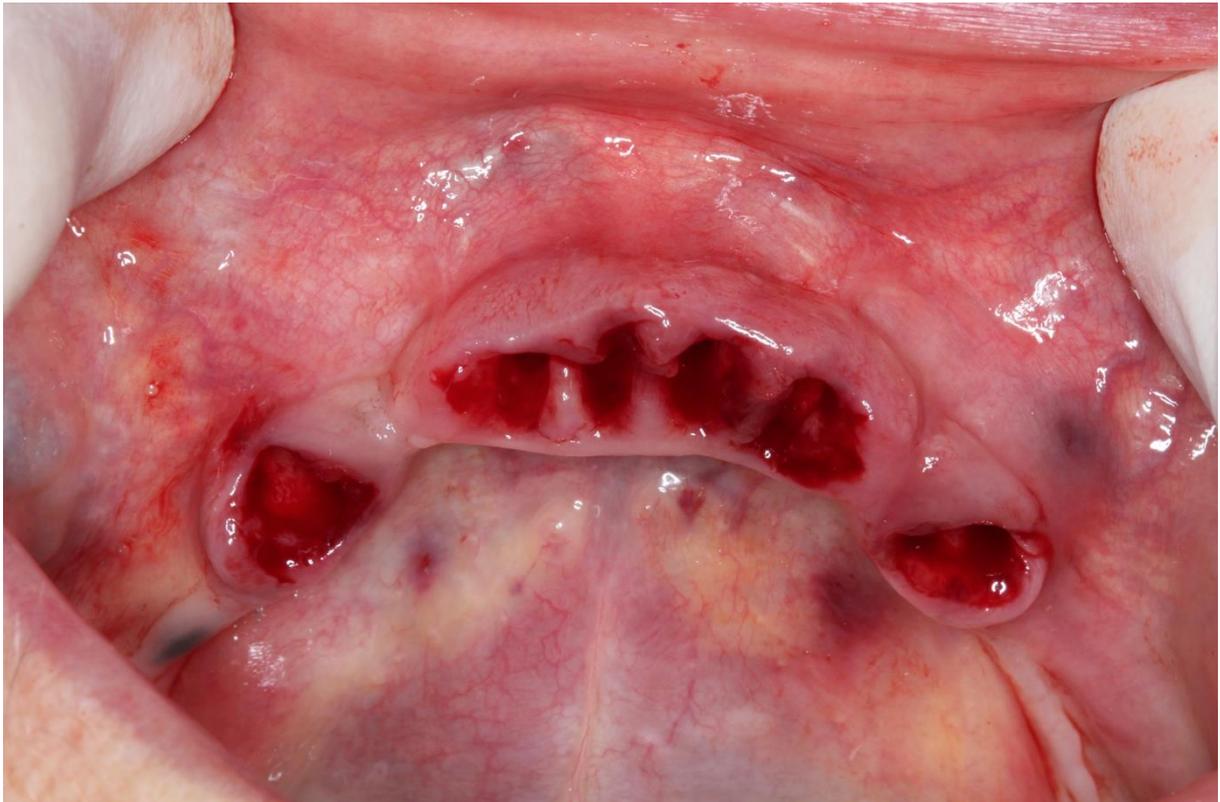
Figure 4: Situation after tooth extraction.

After local anesthesia, the old bridge was cut in four pieces and removed. After that all teeth in the lower jaw were extracted (Figure 4). After inspection of the bone quality around the extraction sites the implants were placed without any incision. Normally, four implants in the lower front are placed in the regions 4 – 2 – 2 – 4. In this case the situation in region 41 was better for implantation than 42, so the implant was placed in region 41 (Figure 5). The pre-fabricated immediate denture was relined to minimize the interference with the implants.

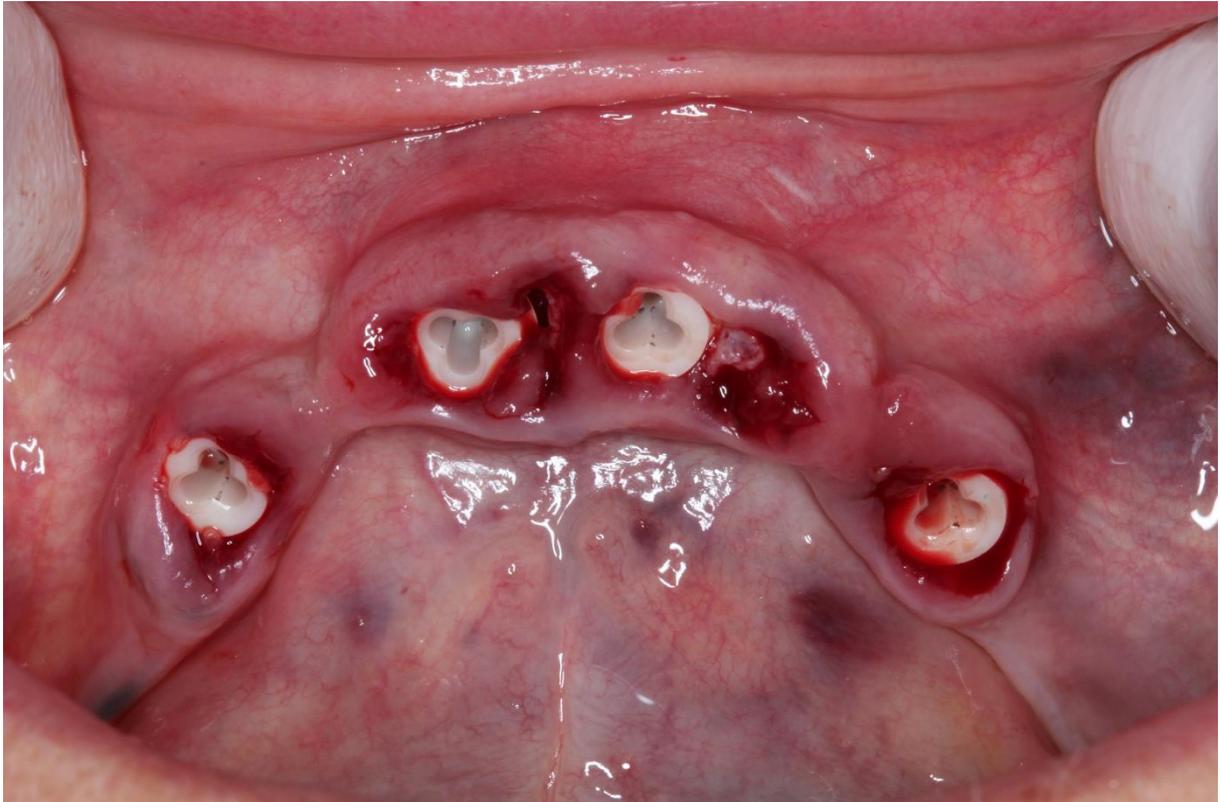
Figure 5: Imediate implant placement without incision.

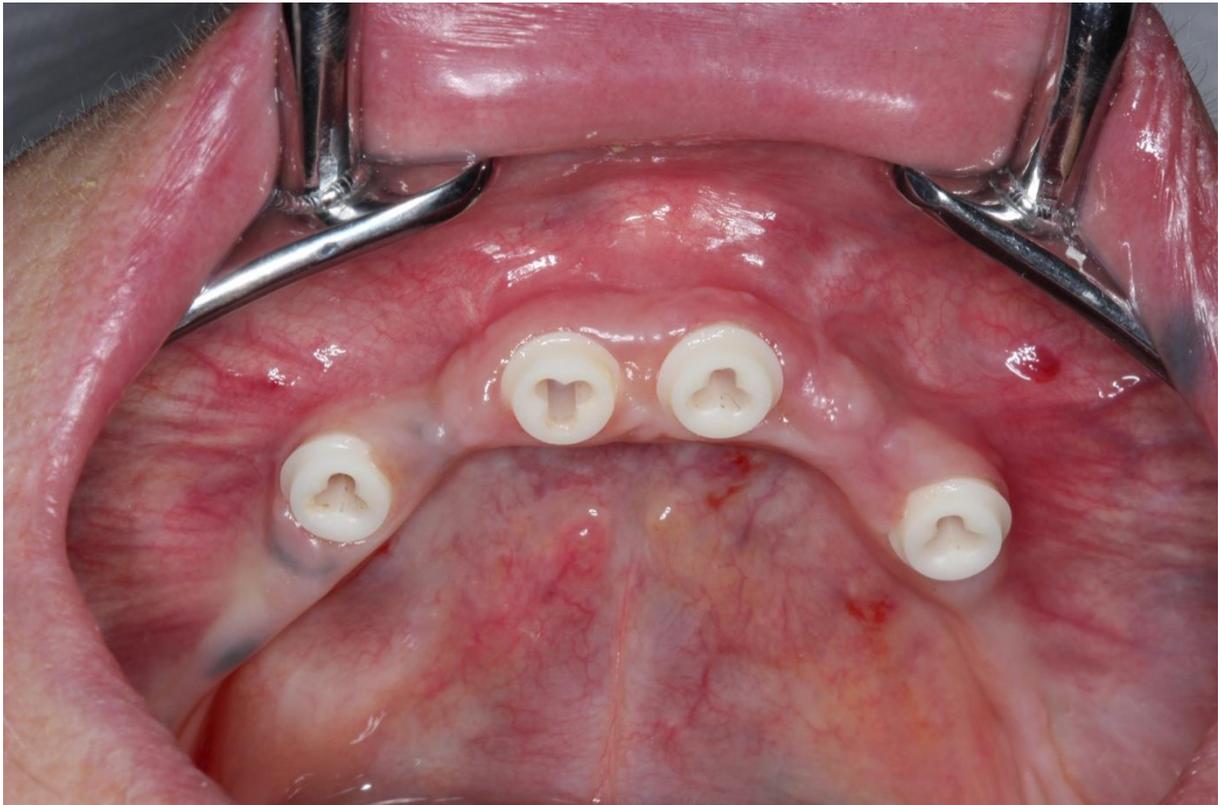
Figure 6: Healing 3 months after implant placement.

After 3 months of healing (Figure 6) the prosthetic work started. First the stability of all implants was evaluated with the Periotest. Typically nominal stability is in the minus range. There are two prosthetic workflows. Either the glass fiber post is cemented on the implant, prepared and a full mouth impression is taken (chair side), or an impression is taken of the implants, including the 3C connection, and the glass fiber posts can be prepared on the model (lab preparation). In this case the lab preparation procedure was chosen. In general patients appreciate if as much as possible is done outside the mouth (Figures 7-9).

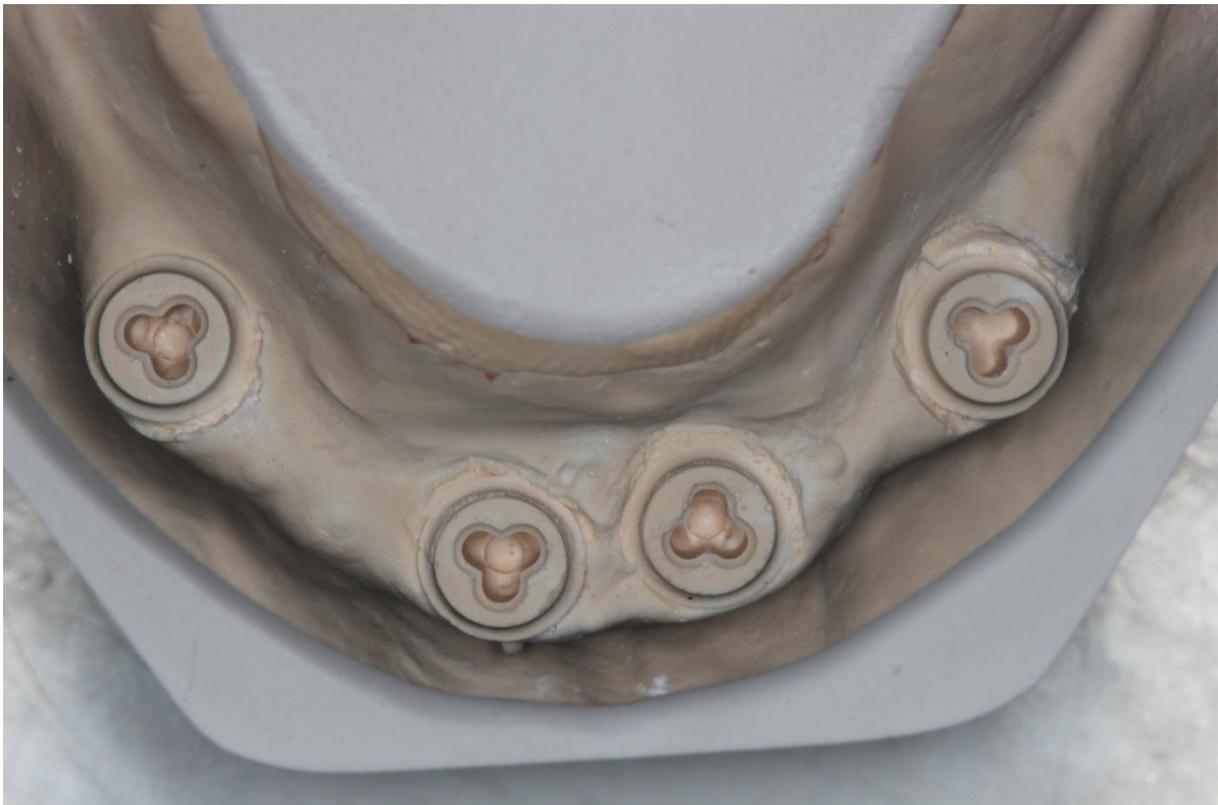
Figure 7. Occlusal view of the model. Note the precise capture of the 3C connection.

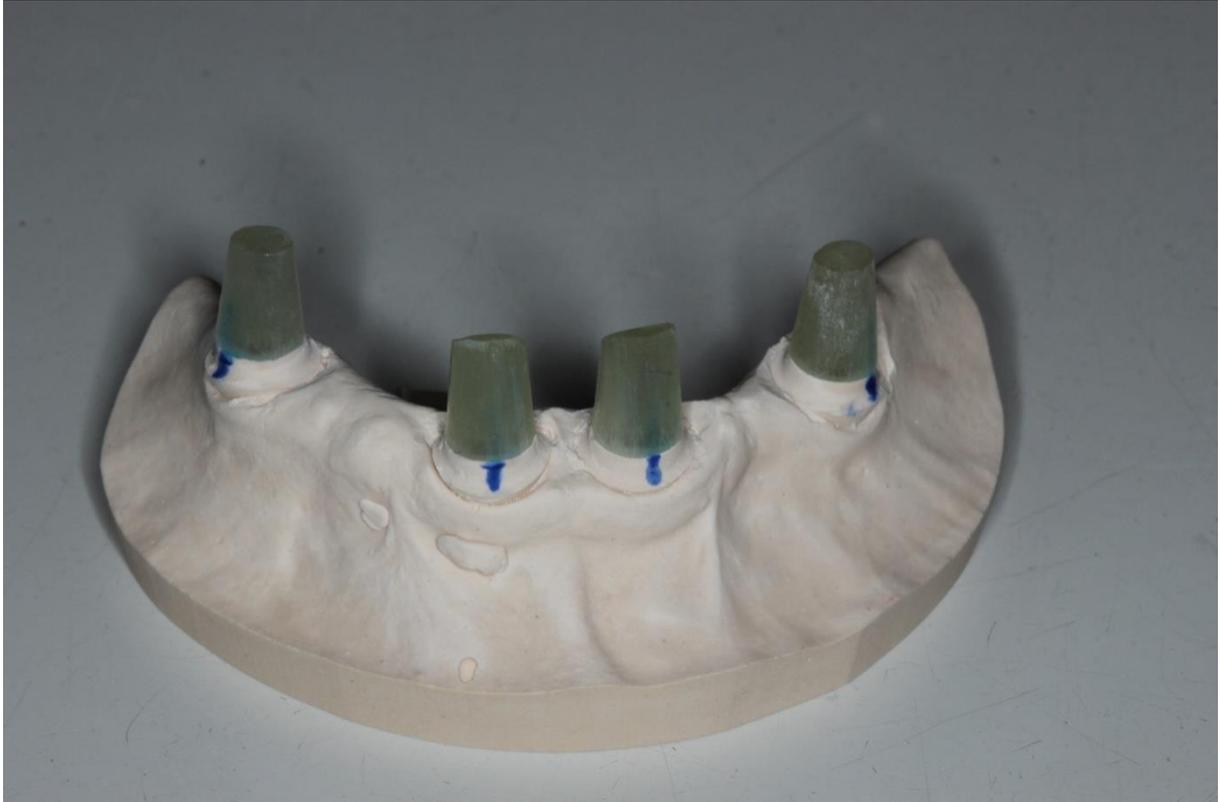
Figure 8: In the lab preparation procedure the technician can prepare the glass fiber posts on the model.

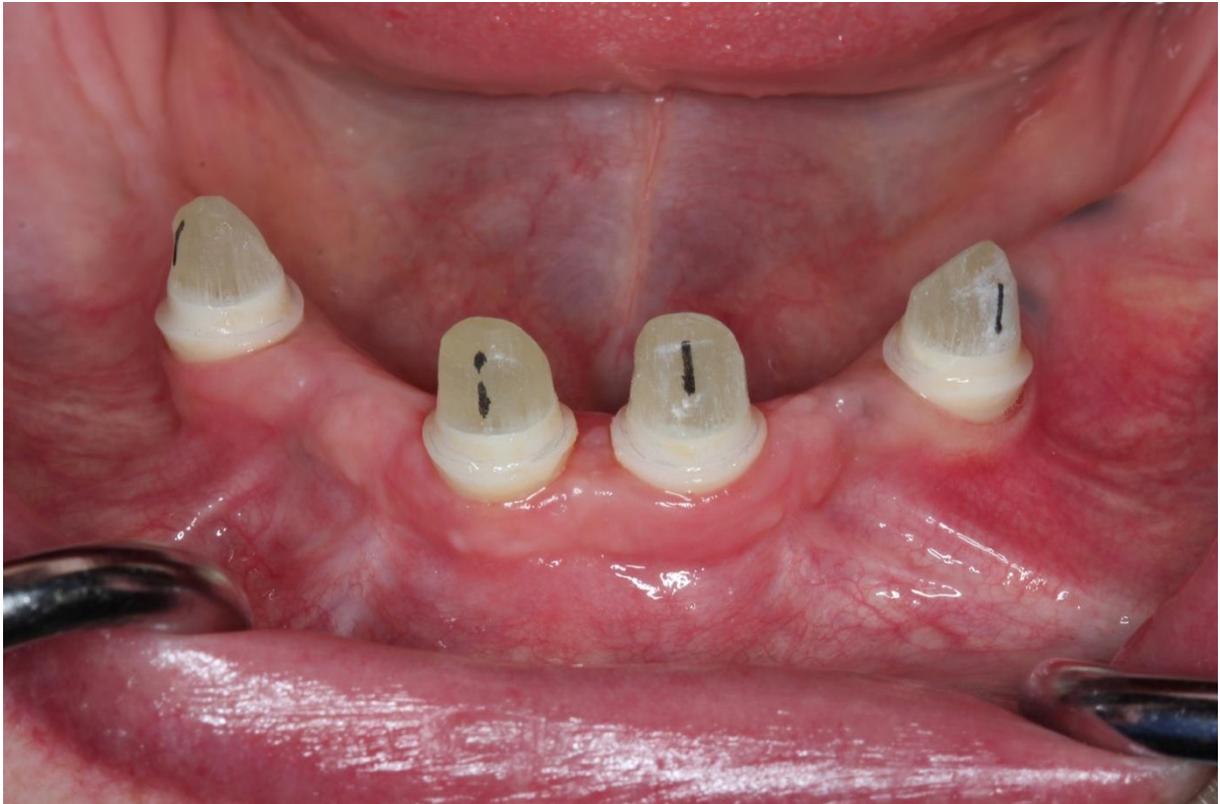
Figure 9: Try-in of the glass fiber posts.

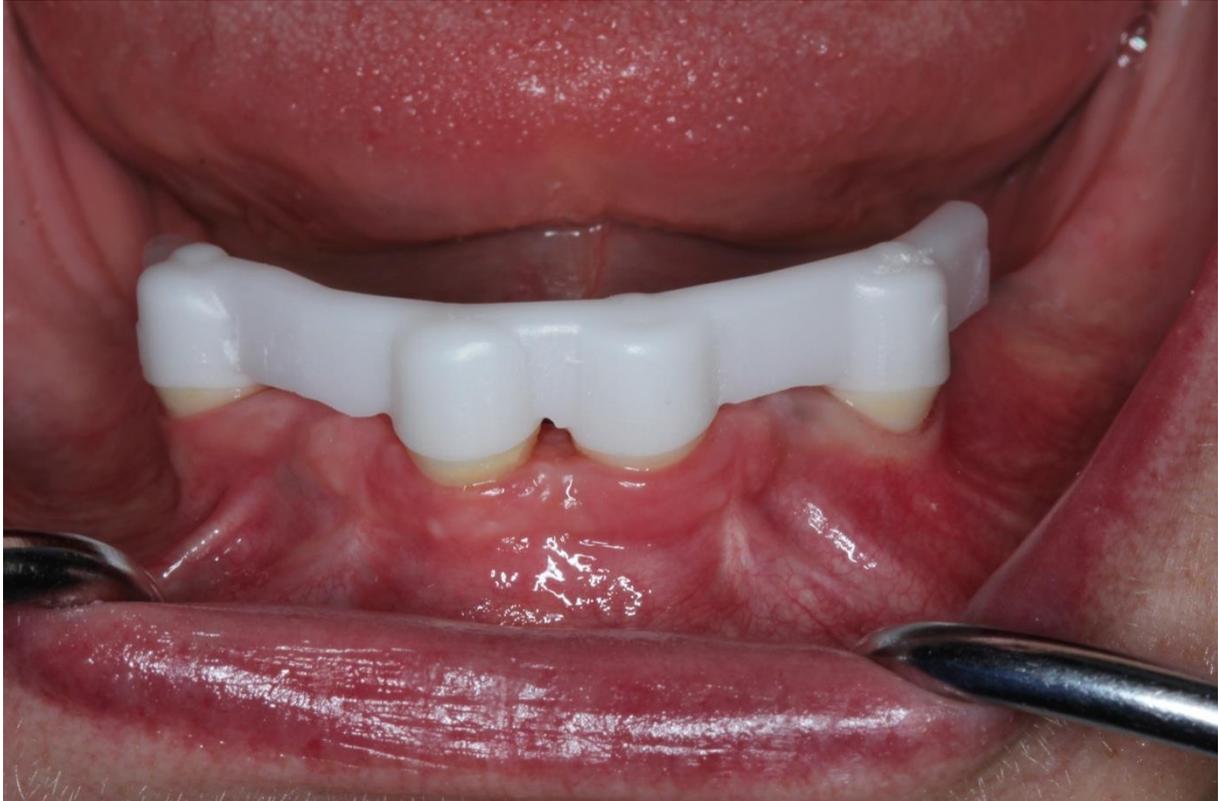
Figure 10: Try-in of the bar.

When the technician has prepared the glass fiber posts, the fit of the posts have to be checked in the mouth. When the fit has been verified, the technician can produce the bar. In addition, the fit of the bar has to be verified in the mouth (Figure 10). When everything has been verified, the technician can finish his work with the overdenture. The secondary retentive element (matrix) was manufactured in PEEK. The glass fiber posts and the bar were cemented with RelayX Unicem2 (Figures 11 and 12).

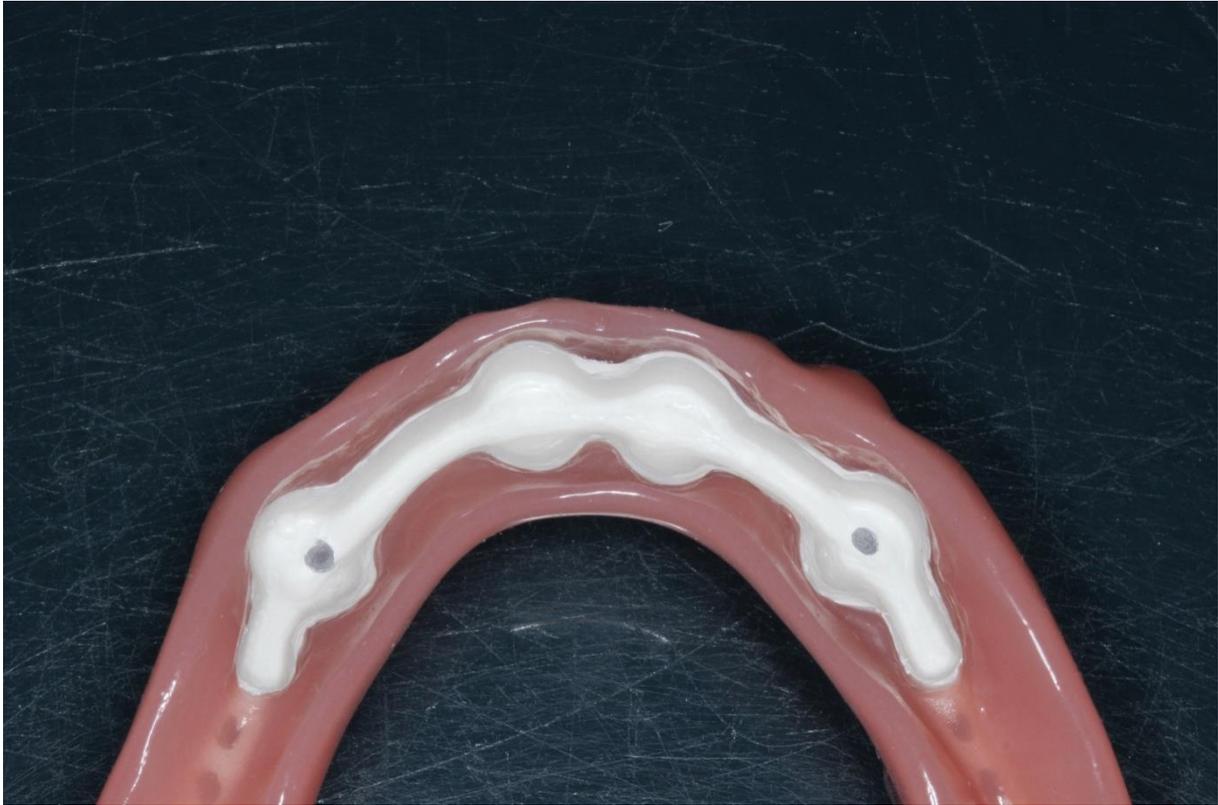
Figure 11. The secondary retentive element fabricated from PEEK integrated in the denture.

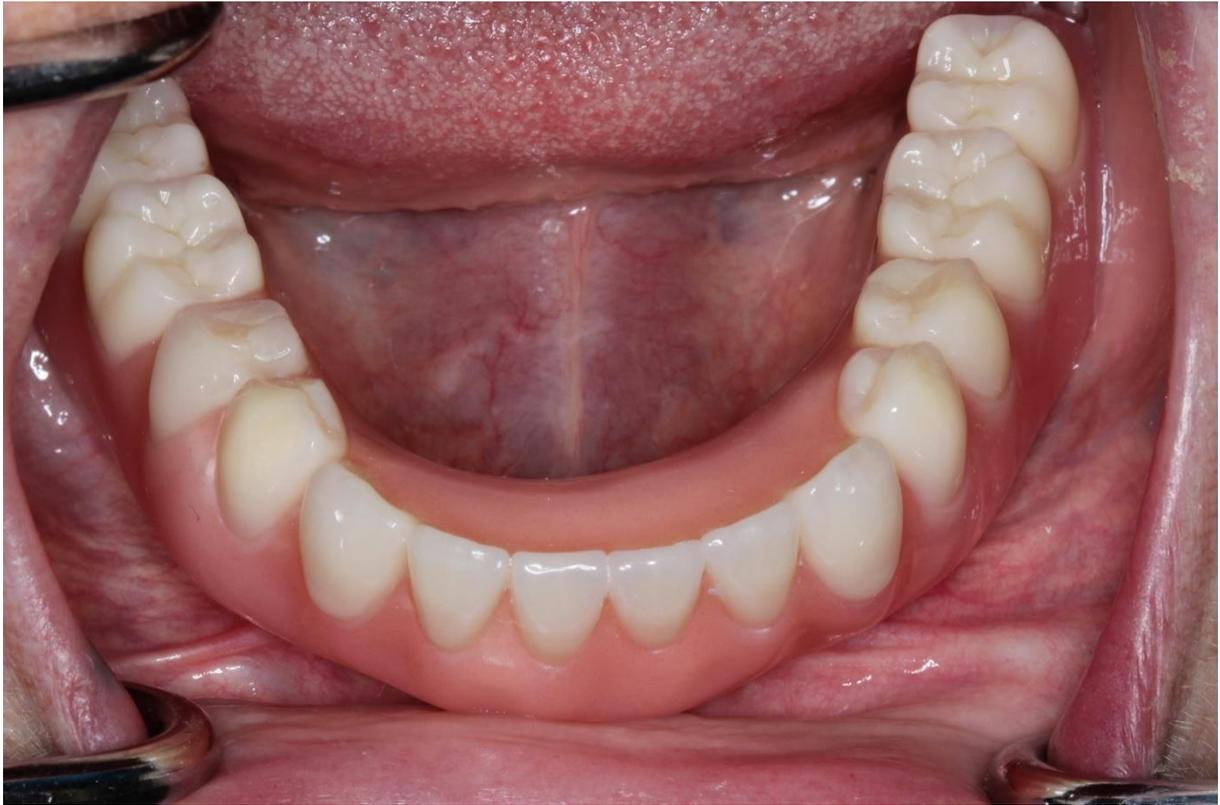
Figure 12: Final denture in place.

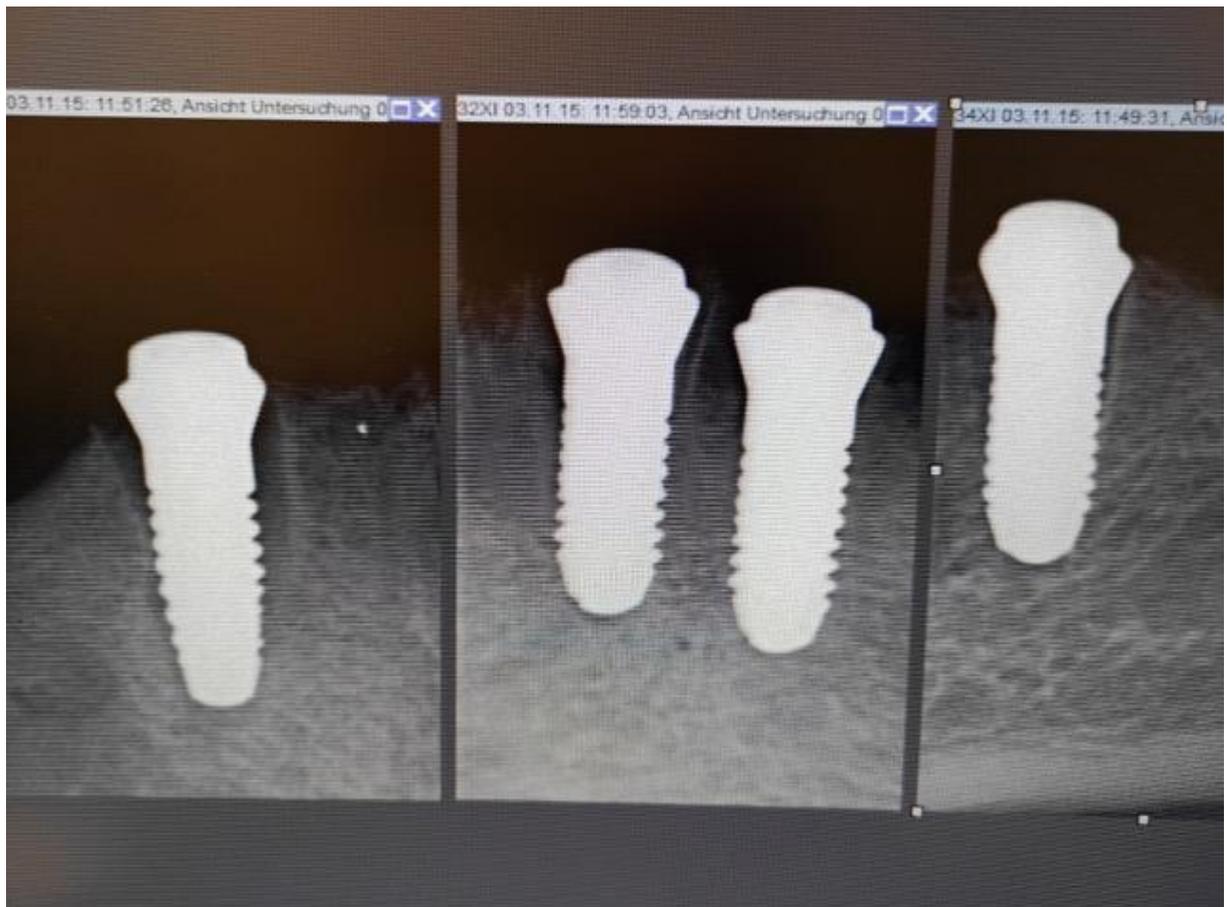
Figure 13: X-rays immediately after implantation. See the gap at the implant 44 (left).

Figures 13 shows the radiographs at the time of implant placement. Please note the bone levels and the gap between the wall of the extraction socket and the implant, especially on the implant in the region 44. Figure 14 shows the radiographs of the situation five years after completion. It shows stable marginal bone levels and a complete closure between bone and implant, especially in region 44.

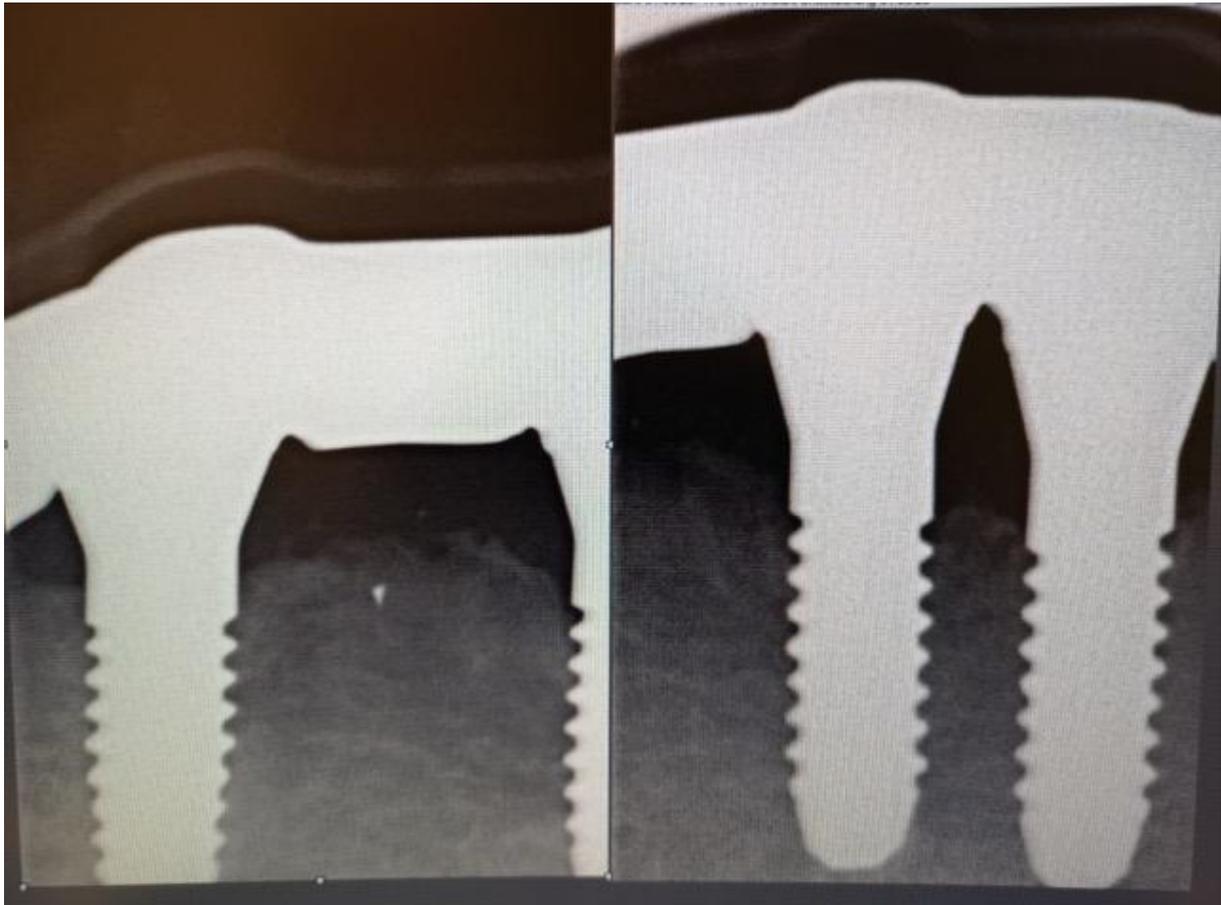
Figure 14: 5 years post op. Maintained marginal bone levels and complete closure of the gap between extraction socket wall and implant in region 44 (left).
